PREVENTING THE NEXT TOWER DISASTER THROUGH ANCHOR INSPECTION

A Pro-Active Guide

Director of Engineering
Hodge Structural Engineers

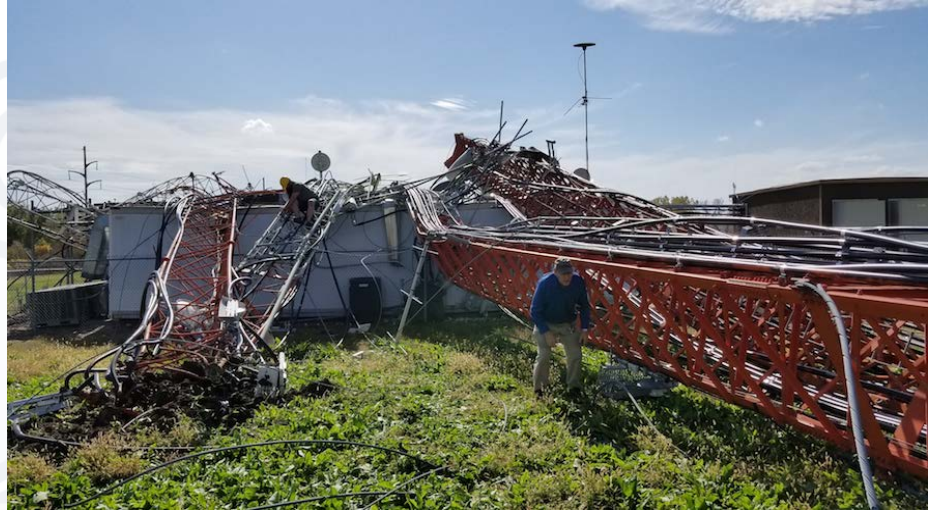
- *Tower failed at 7:55 a.m.*
- *Climbing crew scheduled to arrive at 8:30 a.m.*

Had the anchor shaft held another couple of hours . . .

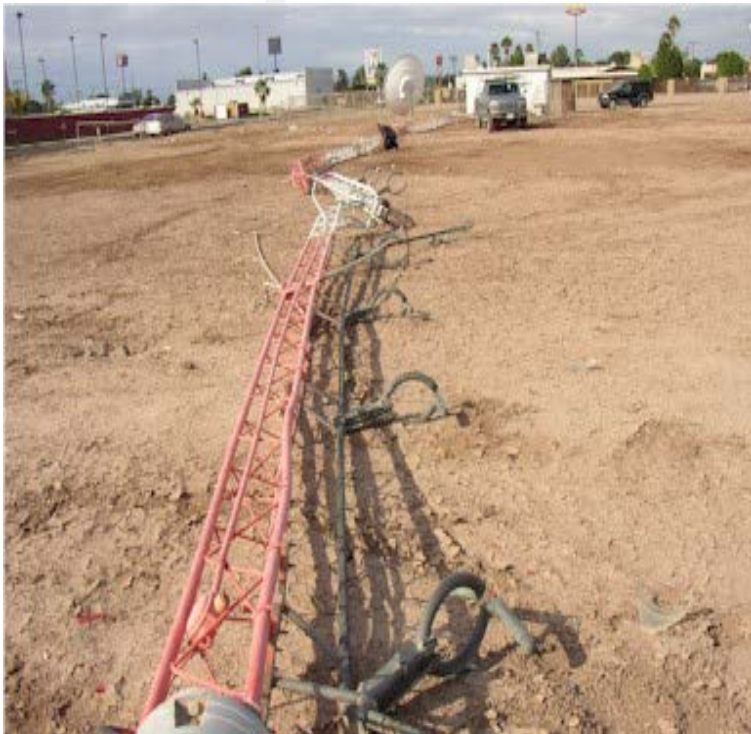
Tulsa, Oklahoma

“The tower had just been inspected. Guy wires were tensioned and everything appeared fine.”

Bettinger stated, “Corrosion was present on the anchor shafts –
several feet below grade.”

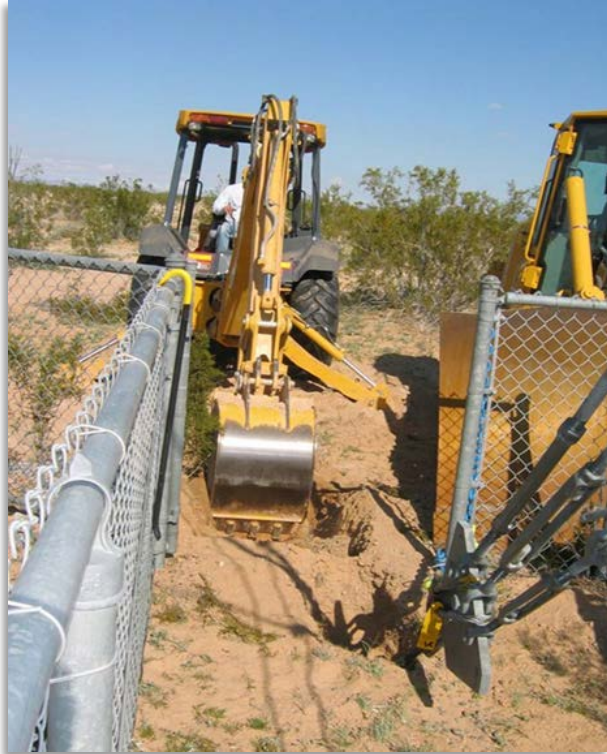
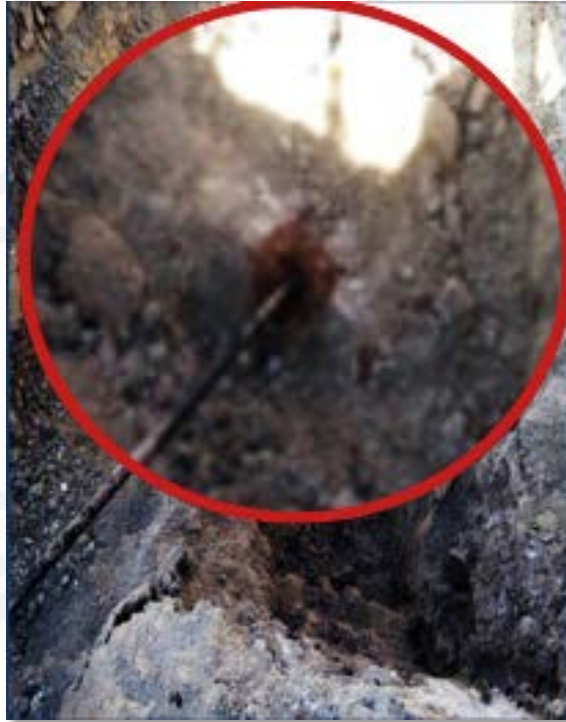
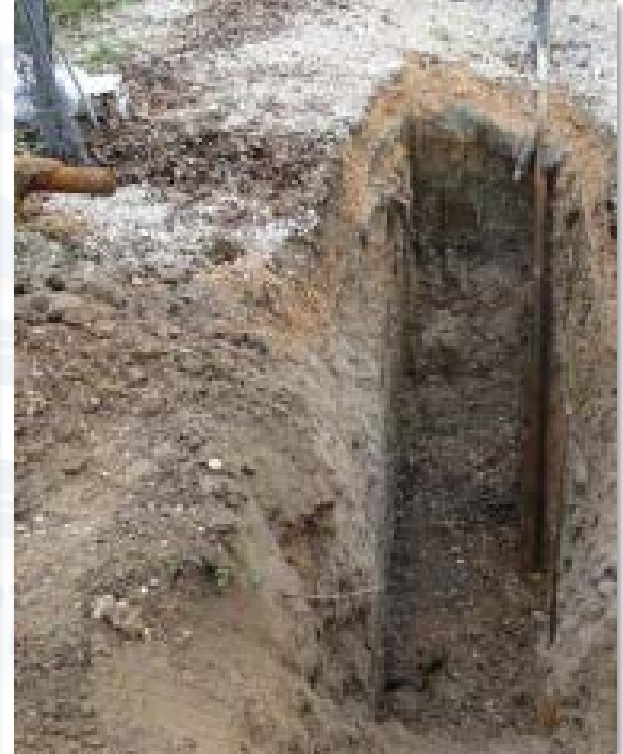
**A DIG-TO-BLOCK PROCEDURE, OR DTB, IS
THE *MOST-CONCLUSIVE METHOD* OF INSPECTING
ANCHOR SHAFTS**

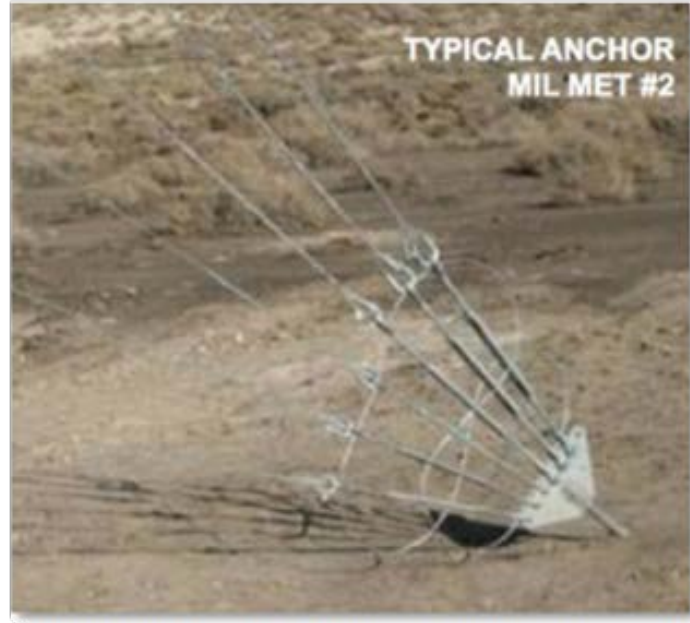
MILFORD MET #2 – TYPICAL ANCHOR – Each of these anchors is in direct contact with soil and has not been equipped with any type of corrosion protection.

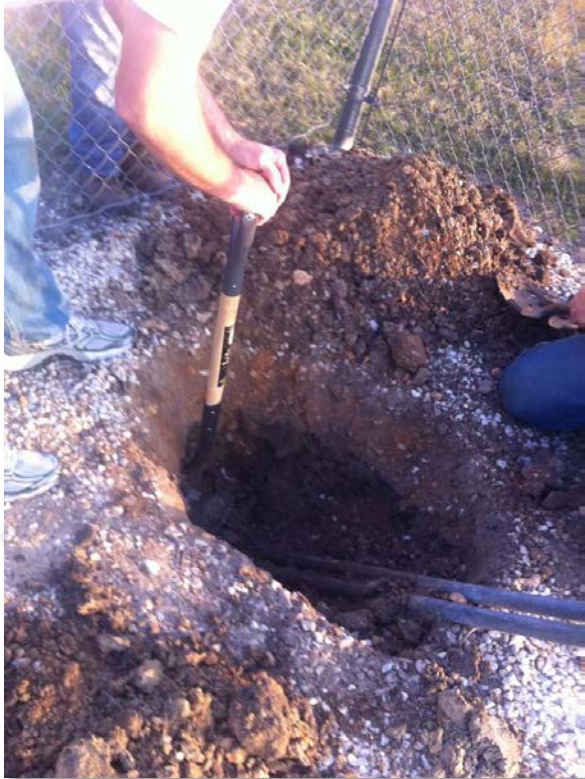
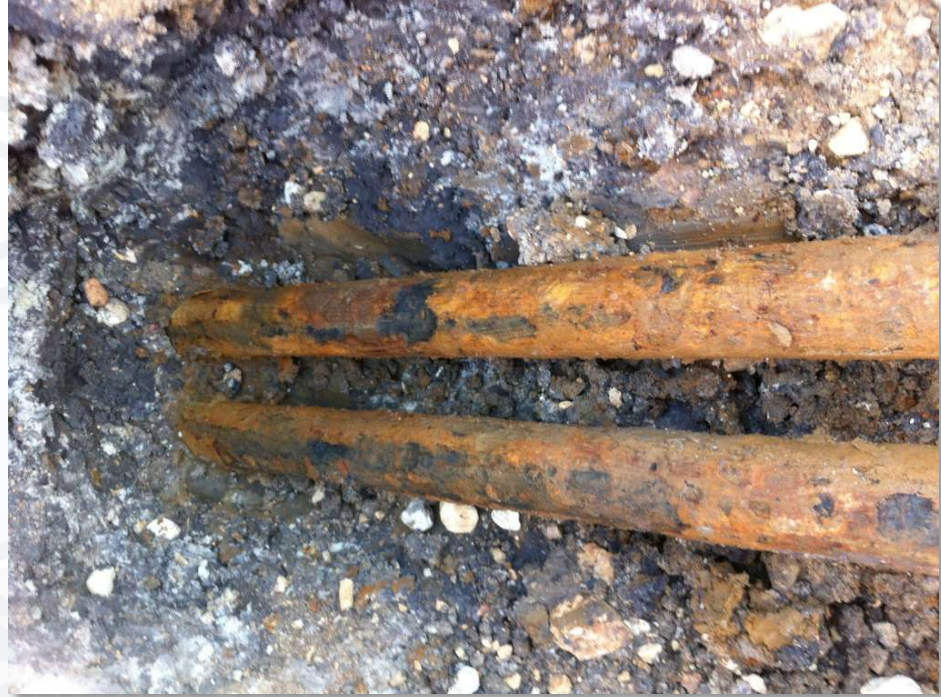
SURFACE INVESTIGATION/PARTIAL EXCAVATION

- 1. Hand tools**
- 2. Excavate 24-36-inches, below grade**
- 3. Caliper measurements and photographs**
- 4. Determine extent of corrosion affecting visible portion of shaft.**

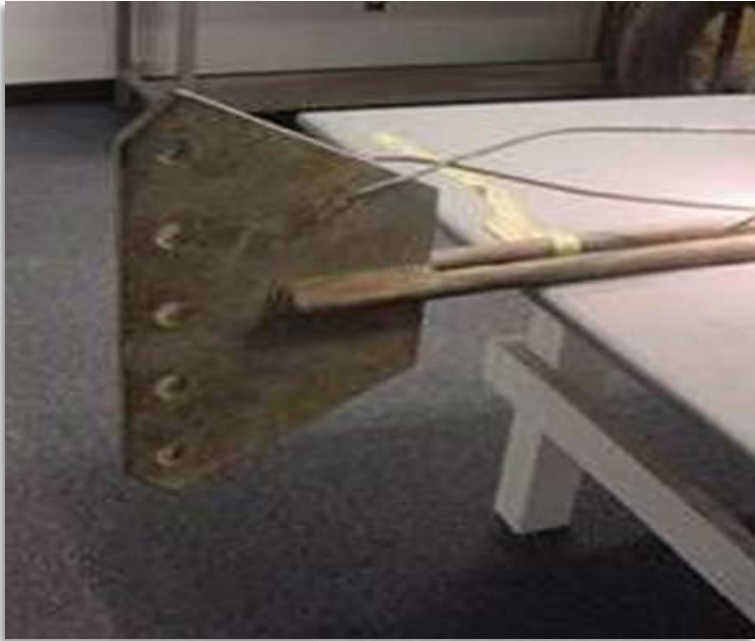
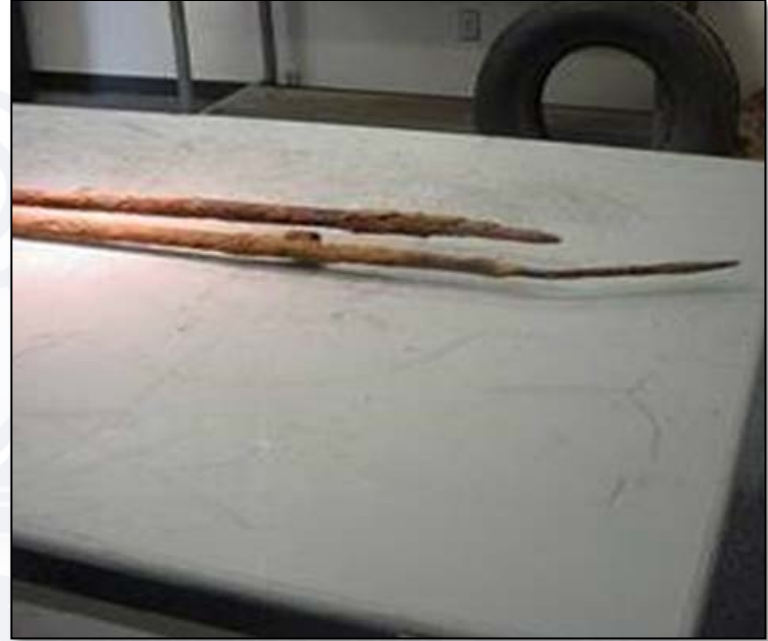
RESULTS OF SURFACE INVESTIGATION/ SHALLOW EXCAVATION CAN BE DECEIVING

The upper 24-inches are not always indicative of rod condition

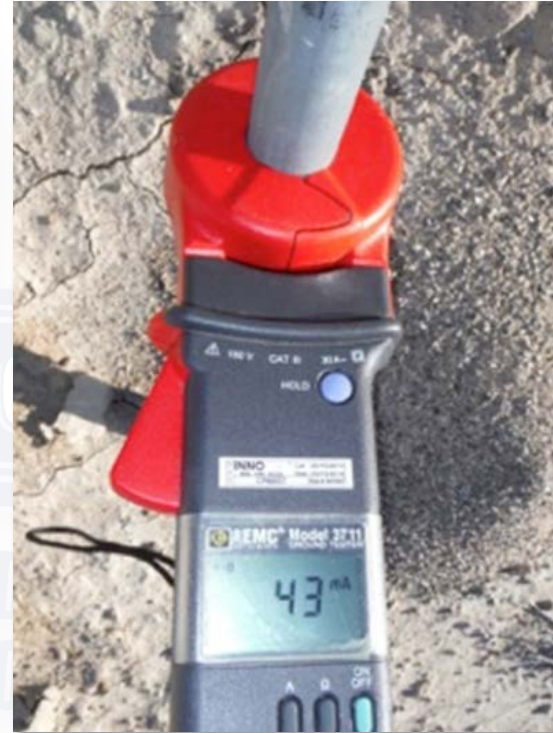
MEASURING RESISTANCE AND CURRENT FLOW

**A SINGLE AMPERE OF DISCHARGED
CURRENT IS CAPABLE OF CORRODING
20-POUNDS OF STEEL, EACH YEAR**

**0.9 lbs. OF STEEL LOSS,
OVER THE COURSE
OF ONE YEAR**

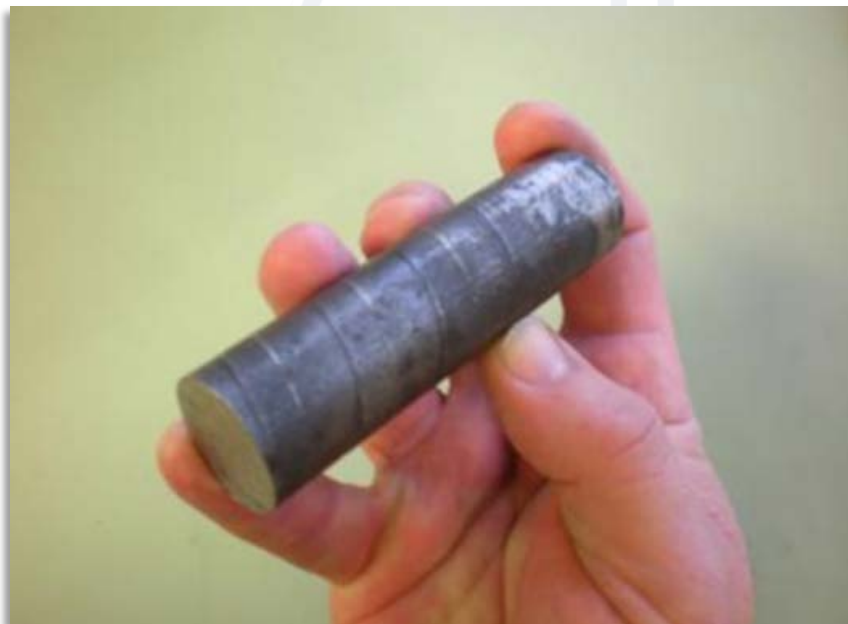
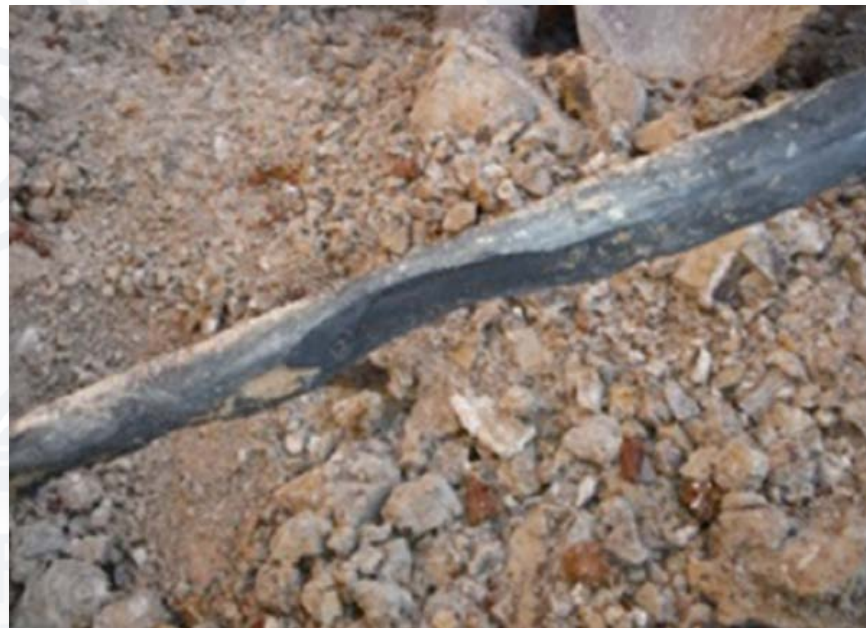
**EVER WONDER WHAT 0.9 POUNDS OF STEEL LOSS LOOKS LIKE,
COMPARED WITH A 2-INCH DIAMETER ANCHOR SHAFT?**

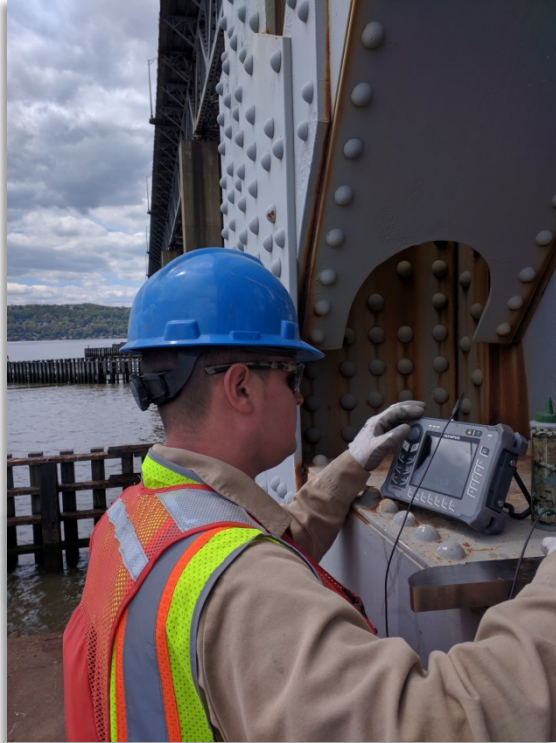
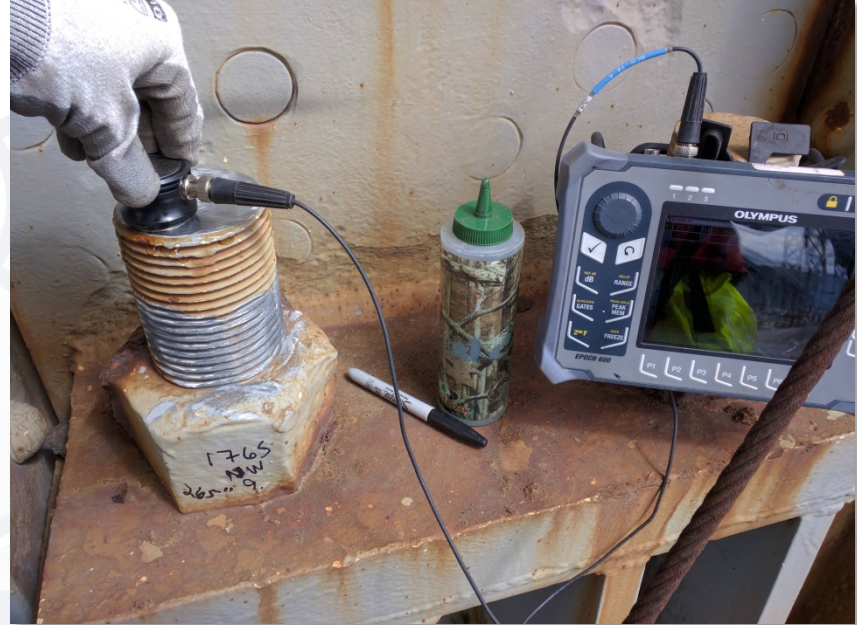
LONGITUDINAL WAVE ULTRASOUND

- **LONGITUDINAL WAVE ULTRASOUND INSPECTION** is a non-destructive method accomplished by projecting a sound beam into the end of a rod to obtain pulse echo reflections.
- Sound waves travel through the material and are reflected by large discontinuities.
- Reflected waves are analyzed to determine the presence and location of flaws.

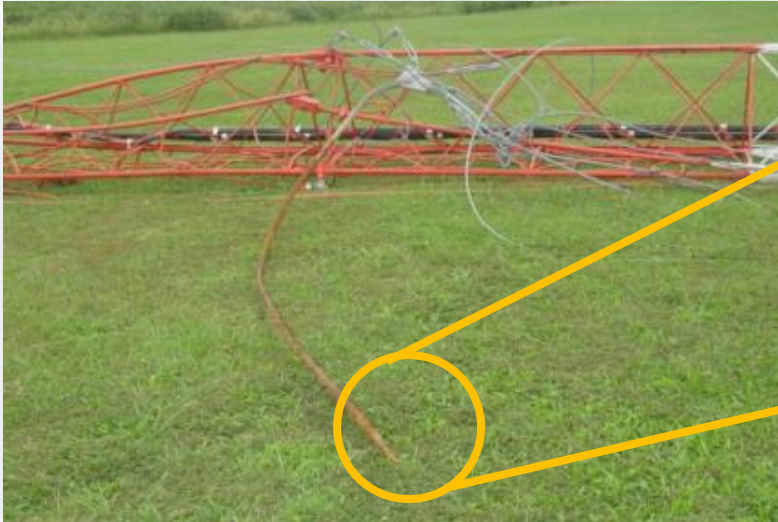
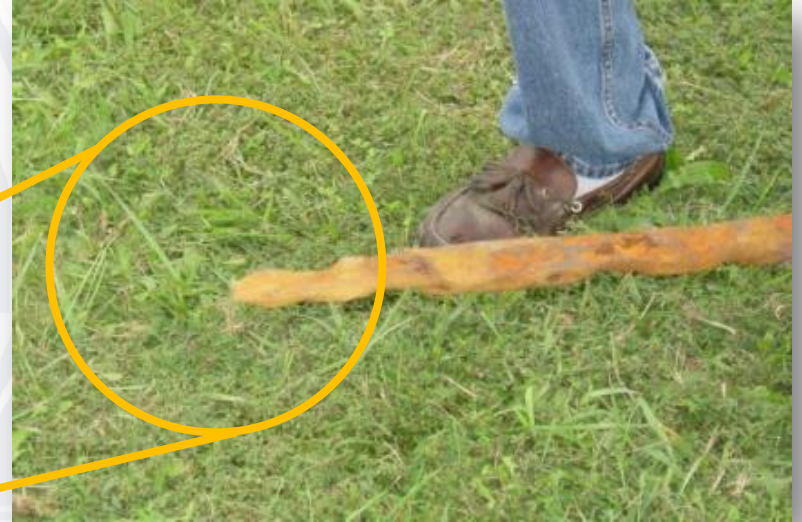
#2 – TOWER INTEGRITY IS COMPROMISED

ADDITIONAL STRESS ON ANCHOR SHAFT COULD LEAD TO FAILURE
